Manhole Inspection Summary

Manhole # S27M__006MH

Inspection ☐ Is Incomplete Rating: **4) Poor**

Location Address: **1167 W Ostend**

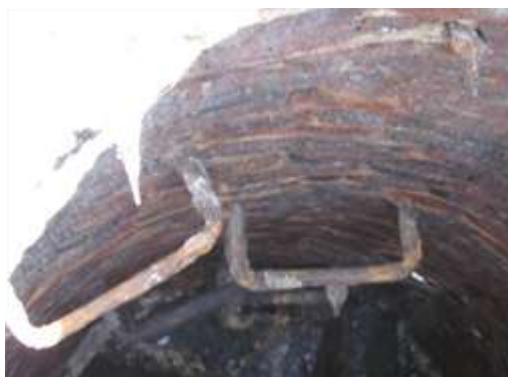
Miscellaneous

Count: **7** Missing: **1** ☒ **Corroded**

Corroded steps

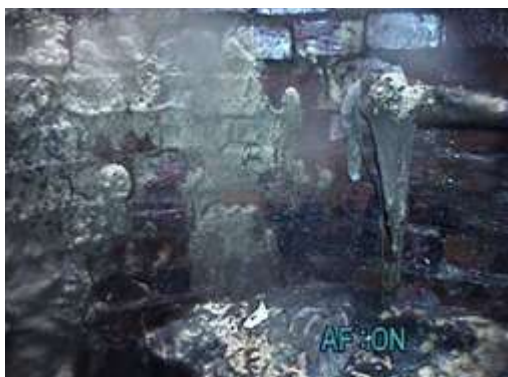
Defect 4

☒ **Evidence Of Surcharge**

Depth: **6**

Evidence of surcharge

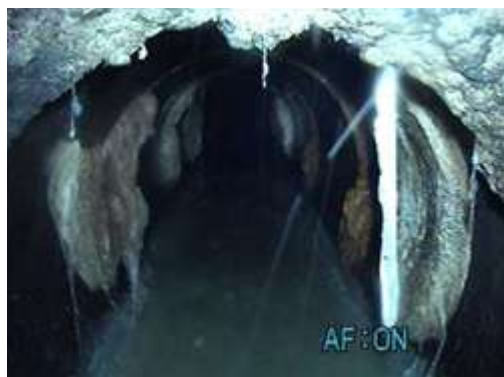
Defect 3

Close-up of pipe deposits in 6

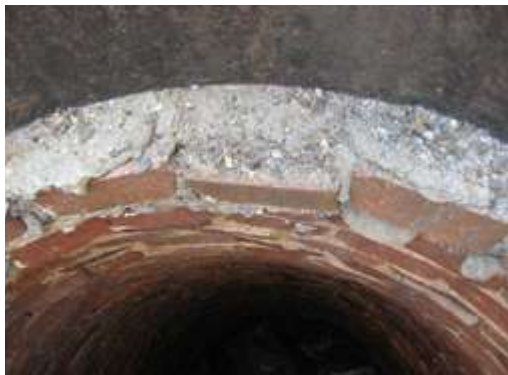
Defect 2

Offset: **2.** (in.)
75

Frame offset 2.75"

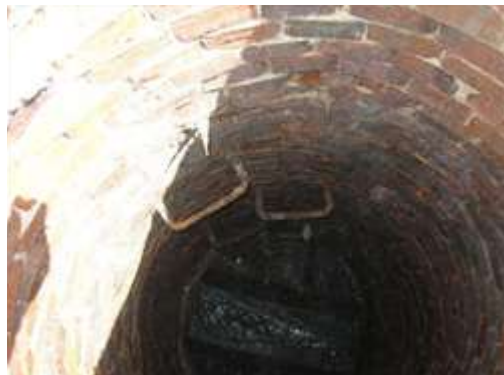
Defect 1

Corroded and oxidized steps

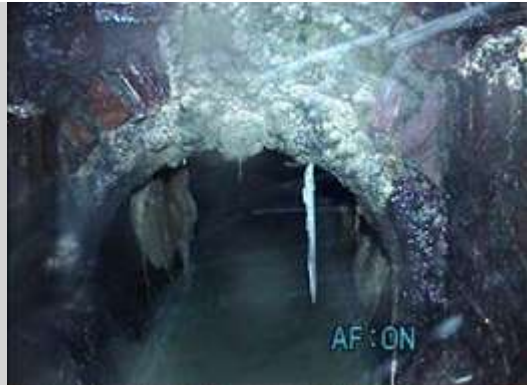
6 O'Clock Inflow

Pipe deposits present

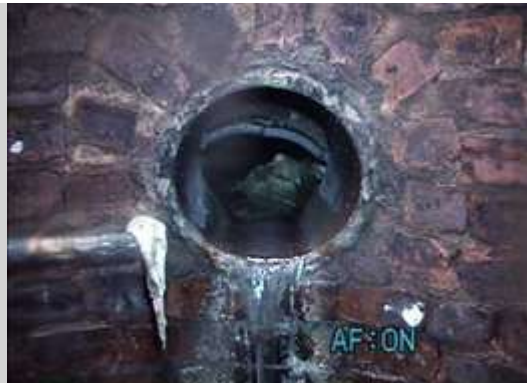
10 O'Clock Inflow

broken pipe upstream at wye fitting for the drop; drop is partially clogged - needs repair

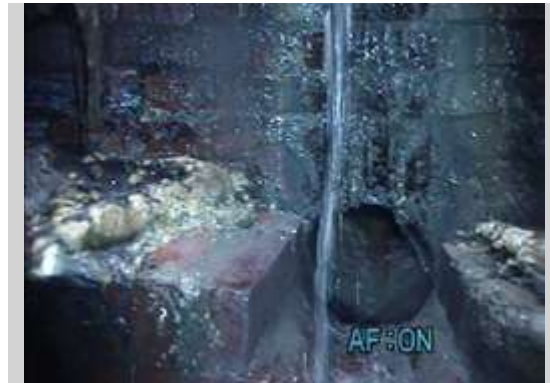
Drop In @ 10 O'Clock

Drop: **Outside** Rod and Bar
Angled: **Yes** Reading: **10.87** (ft.)
Inv Depth: **11.87** (ft.)
Drop Condition: **Partly Clogged**
